INDOOR AIR QUALITY ASSESSMENT

**Woods Memorial Library
19 Pleasant Street
Barre, Massachusetts**

Prepared by:
Massachusetts Department of Public Health
Center for Environmental Health
Emergency Response/Indoor Air Quality Program
January 2006

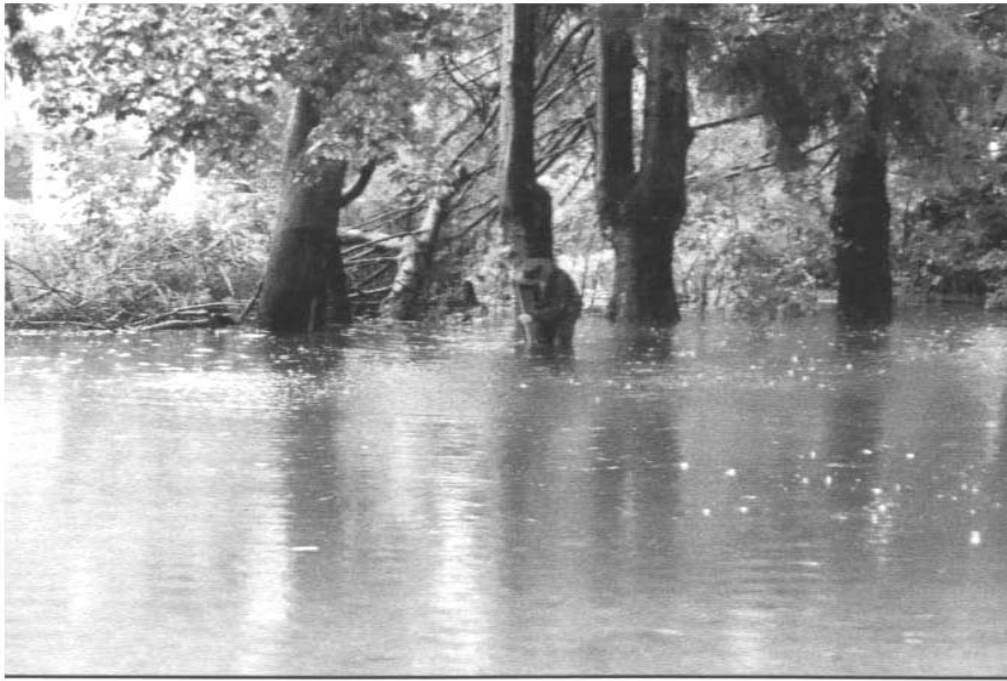
Picture 5

lot that borders semi-wetland, which was flooded with water during the heavy October rains (Picture 5). According to renovation blueprints, a catch basin that predates the renovation project appears to exist in the dirt parking lot (Blueprint 2). CEH staff examined the parking lot and surrounding properties for this catch basin, and could not locate it.

A flash flood produced water over knee-deep at the Woods Memorial Library on Oct. 15, 2005.

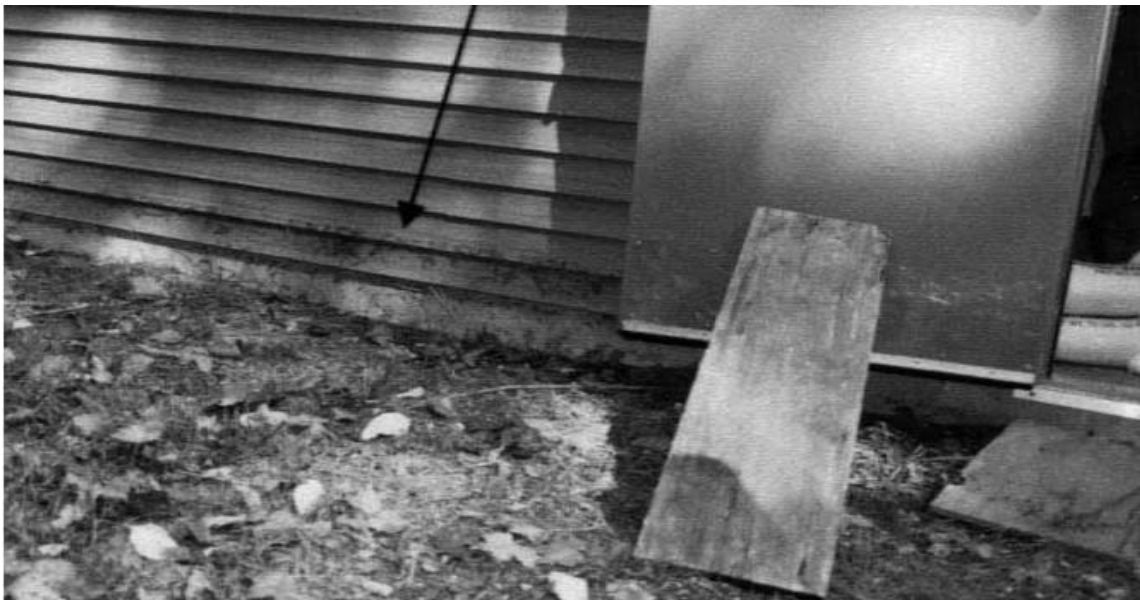
Picture 6

Two days later: on October 17, the water line is evident on the exterior of the building

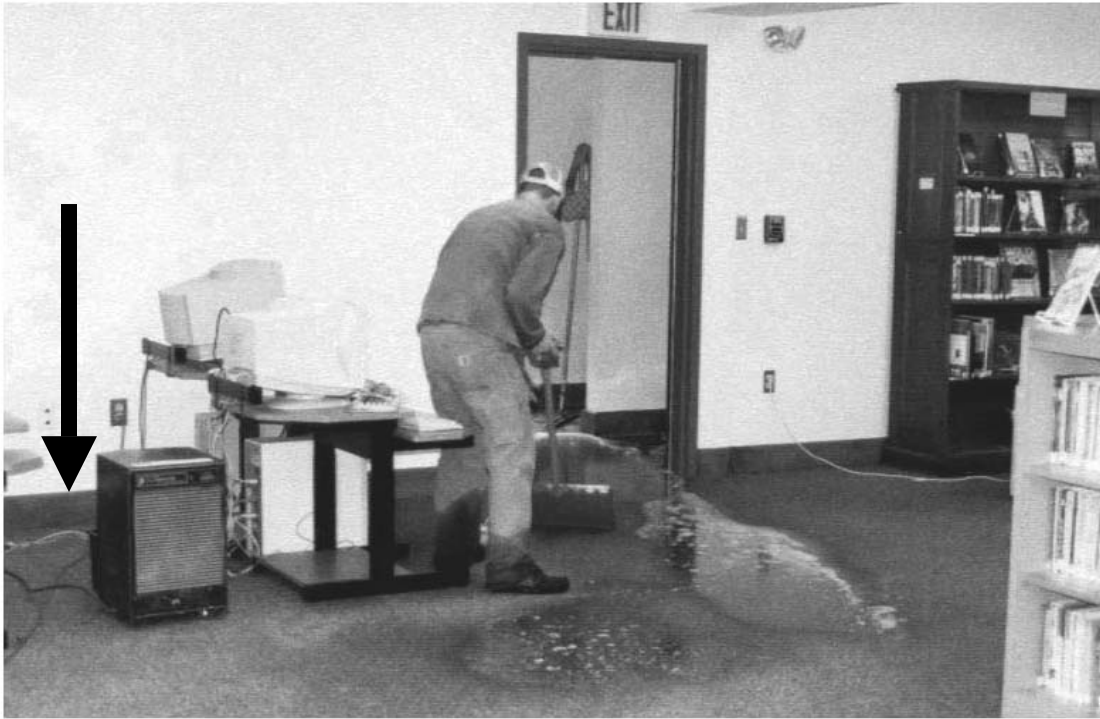
Picture 7

- The wall coving was not removed during the remediation process (Pictures 7 and 8). Wall coving should be removed to aid the drying process during remediation. If it is not removed, GW behind the coving frequently remains wet, which can lead to mold growth.

Flood Cleanup, Note Coving on Wall (Arrow)

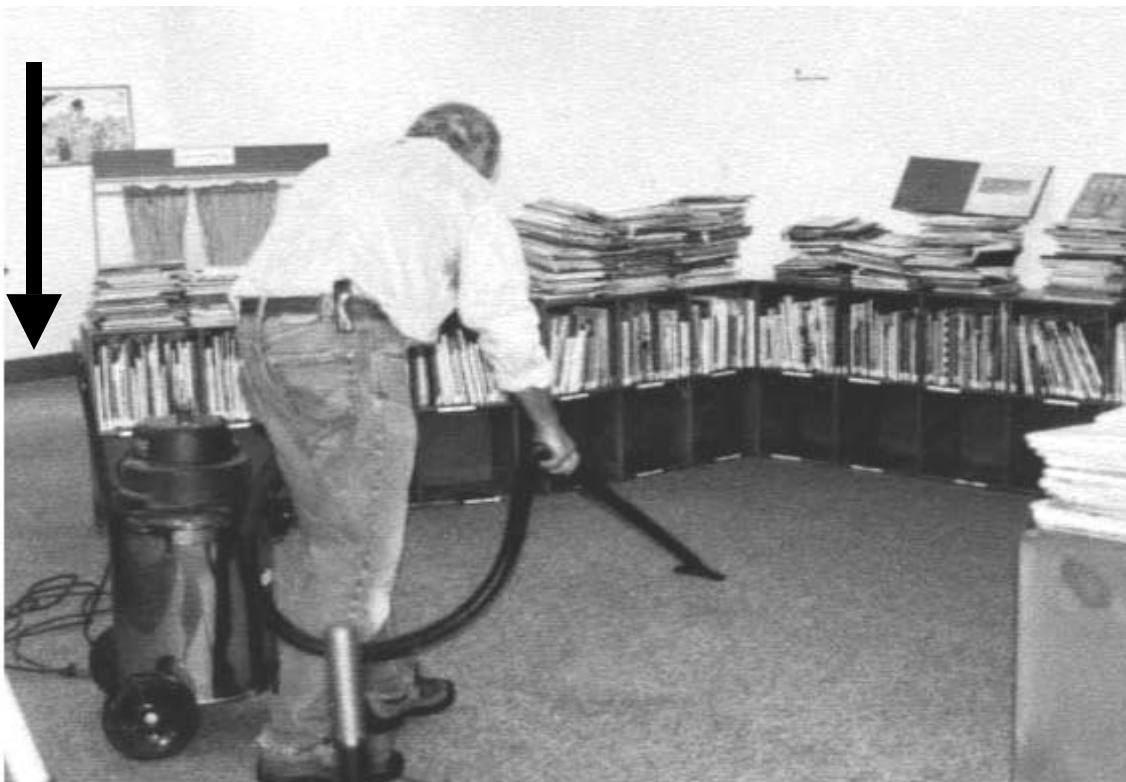
Picture 8

Flood Cleanup, Note Coving on Wall (Arrow)

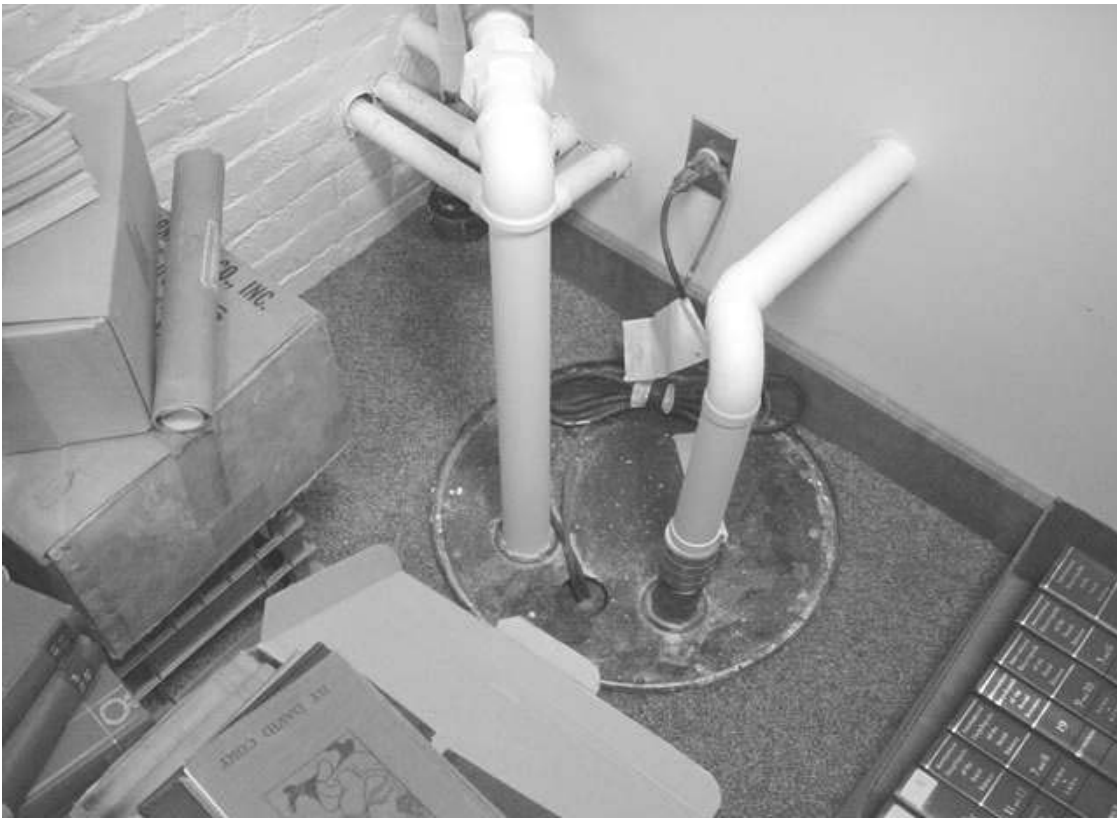
Picture 9

At the time of the assessment the basement appeared to be dry, with relative humidity measurements consistent with measurements in upper floors (which did not come in contact with flood waters). Of significance is the presence of a sump pump in the floor of the original library (Blueprint 3, Picture 9), which indicates that the basement had flooding problems in the past, prior to the renovation.

Sump Pump, Original Building Floor, Note Carpeting Installed up To Edge of Pump Casing

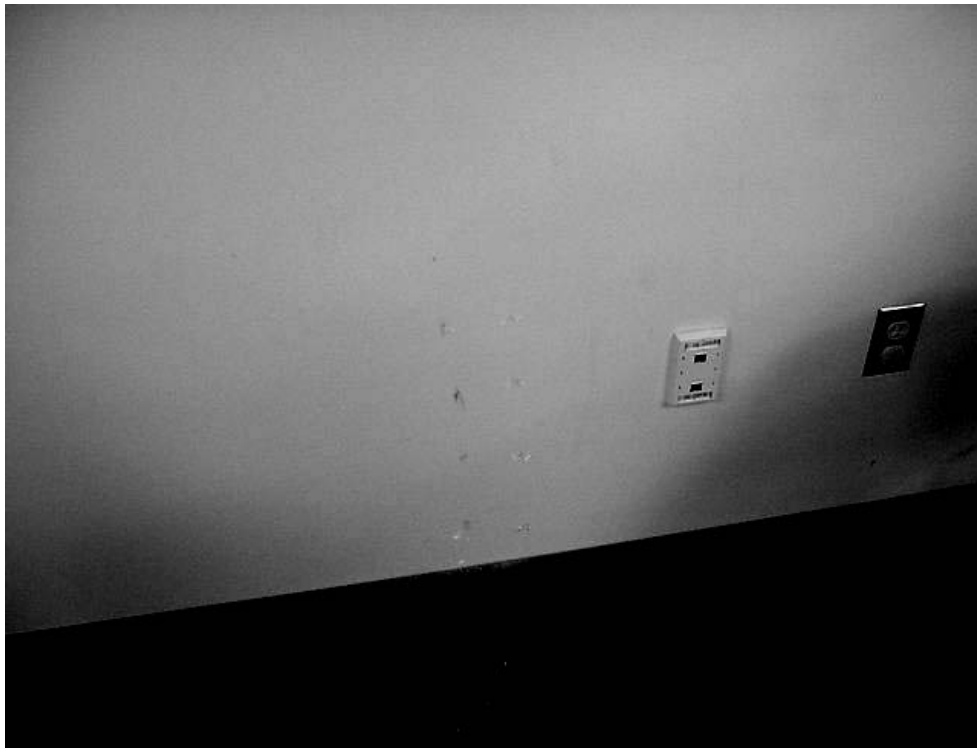
Picture 11

Accumulated moisture was measured in basement GW (Picture 11), carpeting (Picture 12) and wood (Picture 13) that were in contact with flood water. As a comparison, all floor, carpet and wood sampled on the first floor had low (or normal) levels of moisture. These measurements indicate that moisture likely continues to be present in porous basement materials weeks after moistening.

Probe Marks in GW in Basement Exterior Wall

1. Remove water damaged materials (e.g. carpeting, gypsum wallboard and wall insulation) in a manner consistent with recommendations found in “Mold Remediation in Schools and Commercial Buildings” published by the US

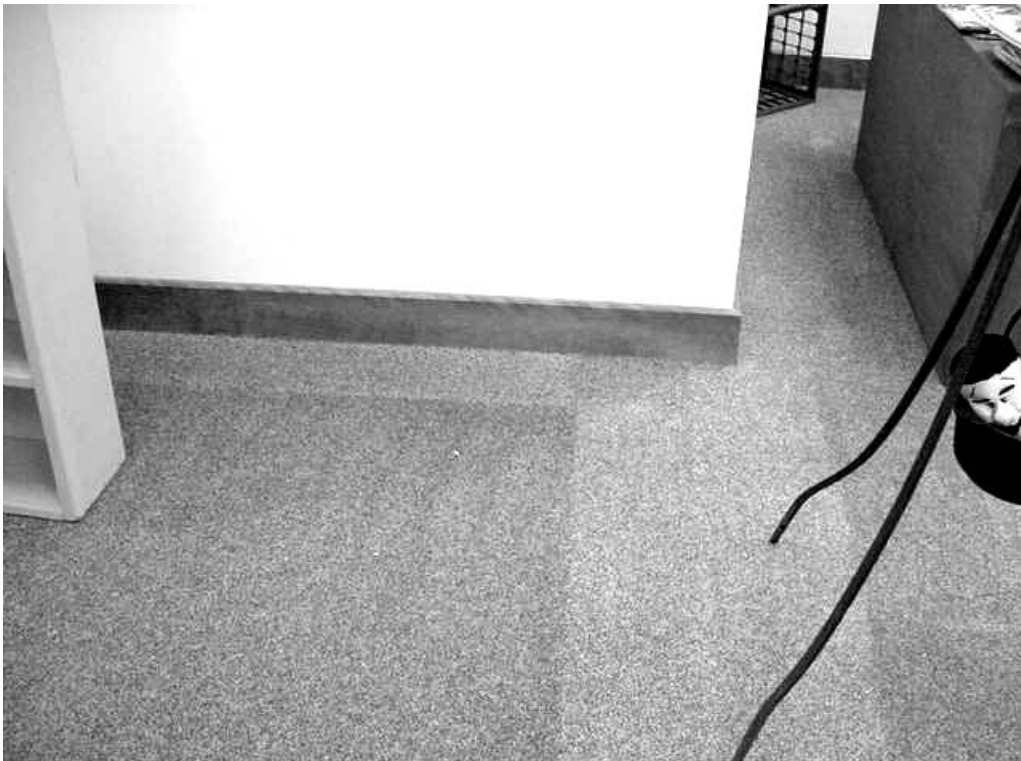
Picture 12

Carpeting Stained With Water Sediment

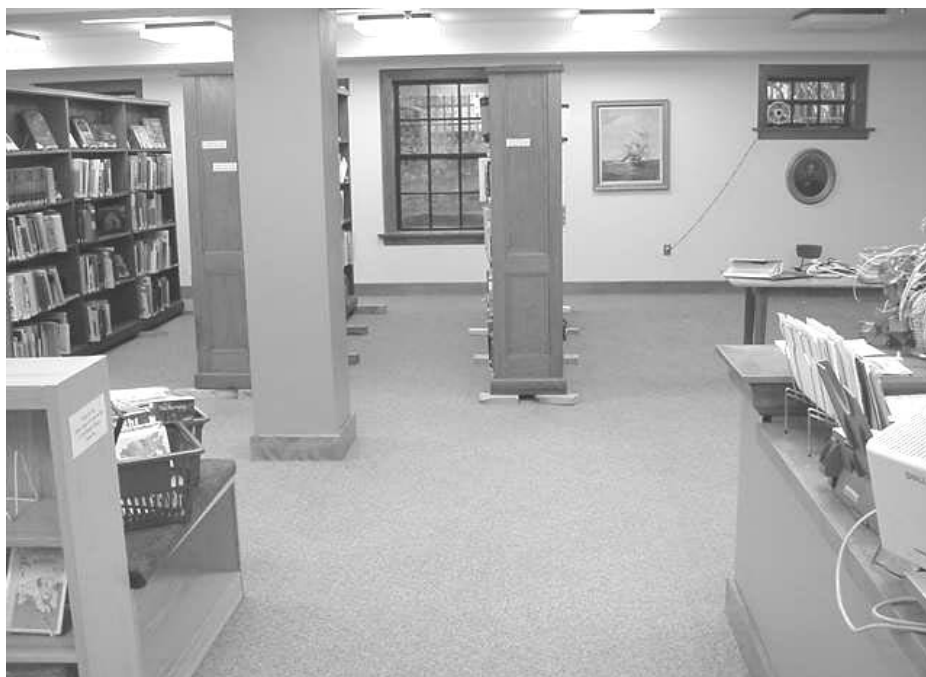
Picture 13

Shelves with Moisture Reading at Its Base, Top of Shelves Had Low (Normal) Moisture Measurements

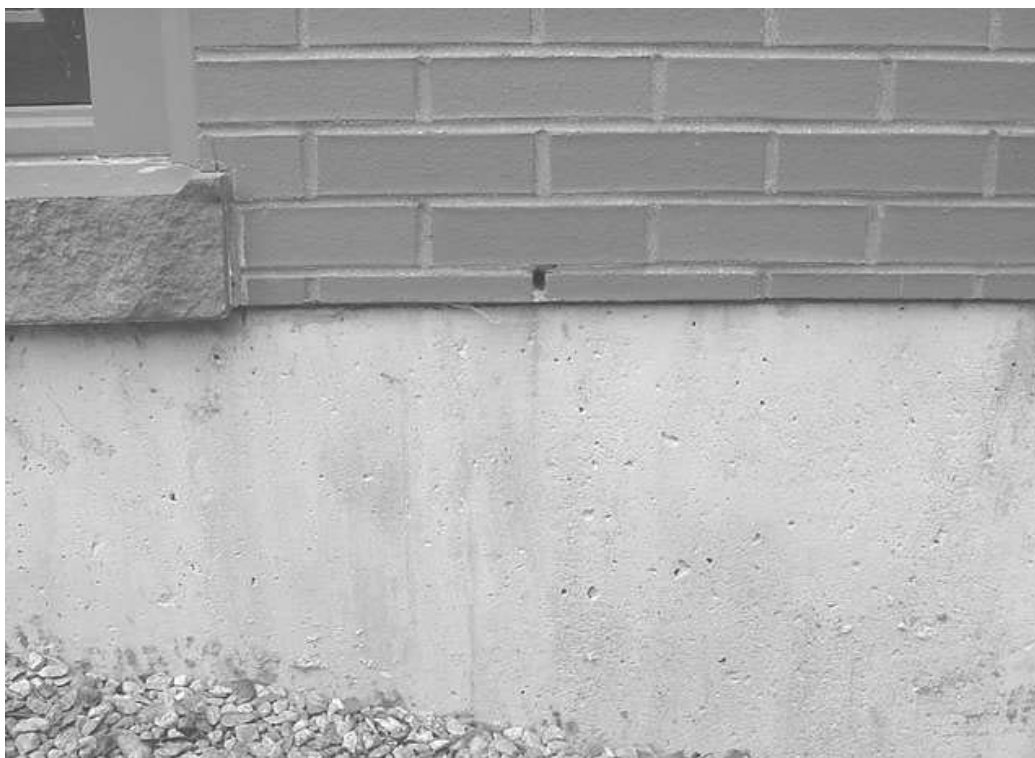
Picture 14

holes were found above grade. Some weep holes in these walls were open (Picture 14). Of note is that some weep holes were blocked with a wick material (Picture 15). Wicks were originally installed to enhance water movement from the drainage plane. Over time, sediment accumulation turns the wick into a stopper, which prevents water drainage from the exterior wall system. It is not recommended to “use ropes or tubes for weep [hole]s” (Nelson, P.E., 1999).

Open Weep Holes

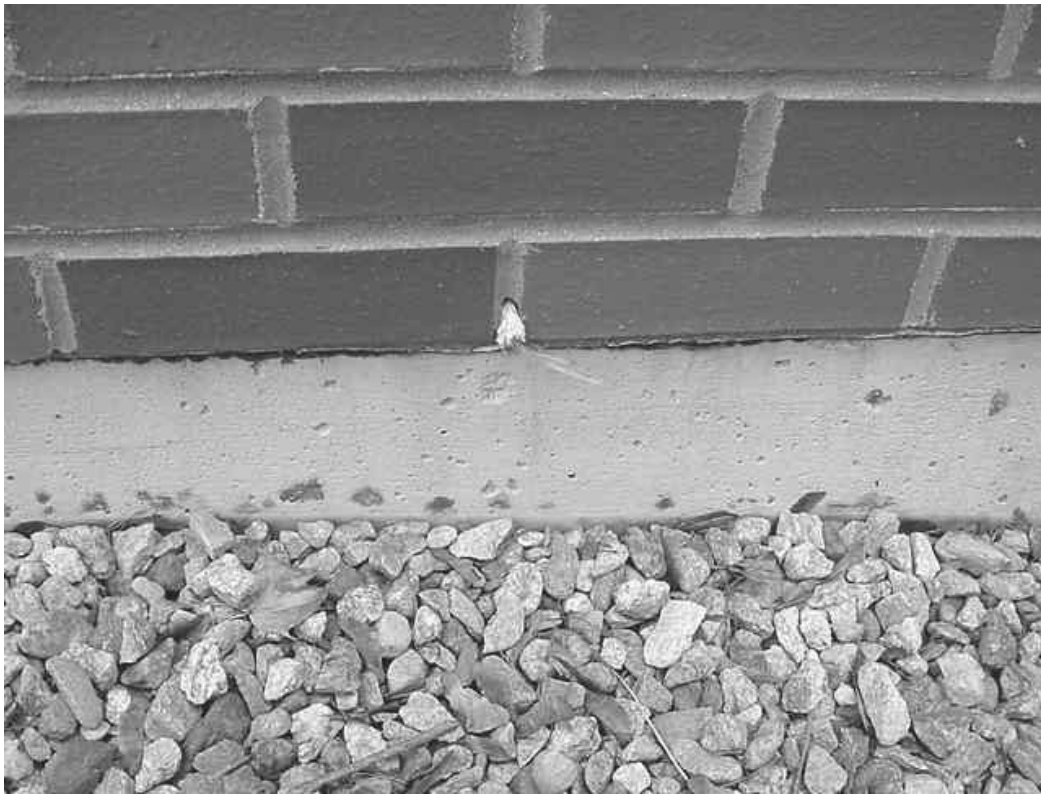
Picture 15

Wick-ed Weep Hole

- air filter (HEPA) equipped vacuum cleaner is recommended. Non porous materials (e.g., linoleum, cement) should be disinfected with an appropriate antimicrobial agent is recommended. Non-porous surfaces should also be cleaned with soap and water after disinfection.
14. For buildings in New England, periods of low relative humidity during the winter are often unavoidable. Therefore, scrupulous cleaning practices should be adopted to minimize common indoor air contaminants whose irritant effects can be enhanced when the relative humidity is low. To control for dusts, a high efficiency particulate arrestance (HEPA) filter equipped vacuum cleaner in conjunction with wet wiping of all surfaces is recommended. Drinking water during the day can help ease some symptoms associated with a dry environment (throat and sinus irritations).
 15. Remove wicks from all weep holes.

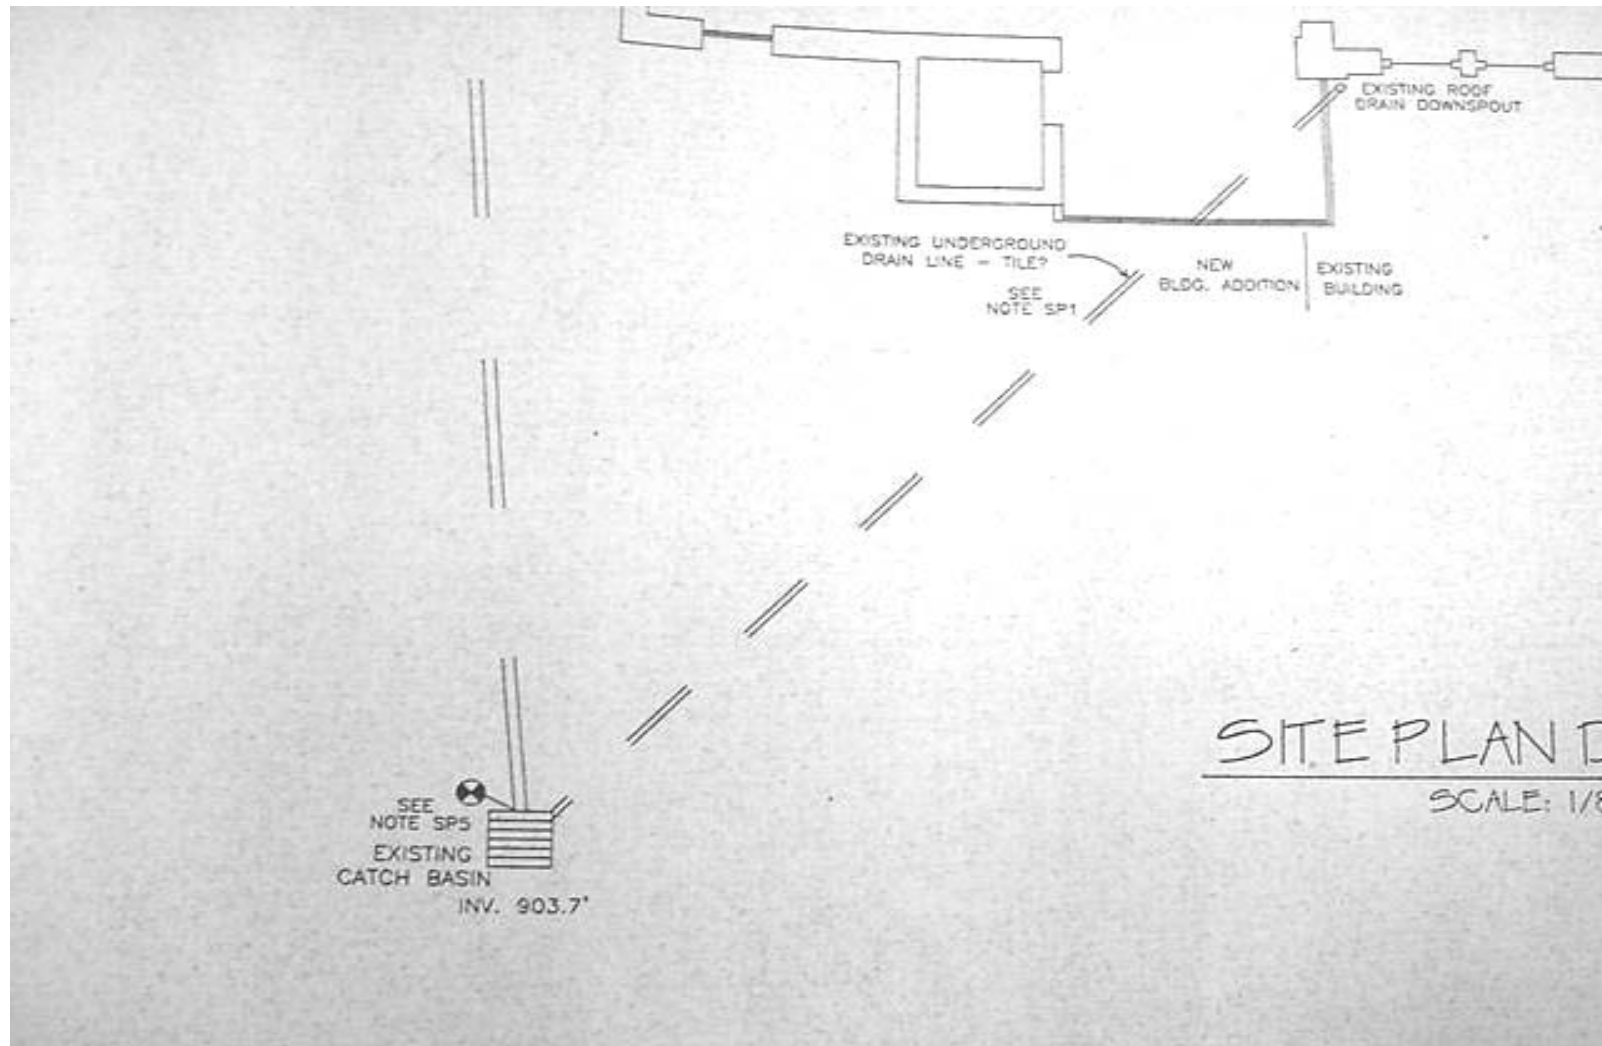
Blueprint 2

Blue Print Indicating That a Catch Basin Exists Near the WML Property Lot

1. Identify if a catch basin exists to drain the parking lot. If no catch basin exists, measures should be considered to improve drainage from the parking lot.
2. Consider constructing a concrete dike around the basement entrance of sufficient height to prevent water penetration.
3. Given that the library has sump pumps in its basement floor, it is strongly recommended not to install wall-to-wall carpeting in the basement. A non-porous, easily cleanable surface should be used.

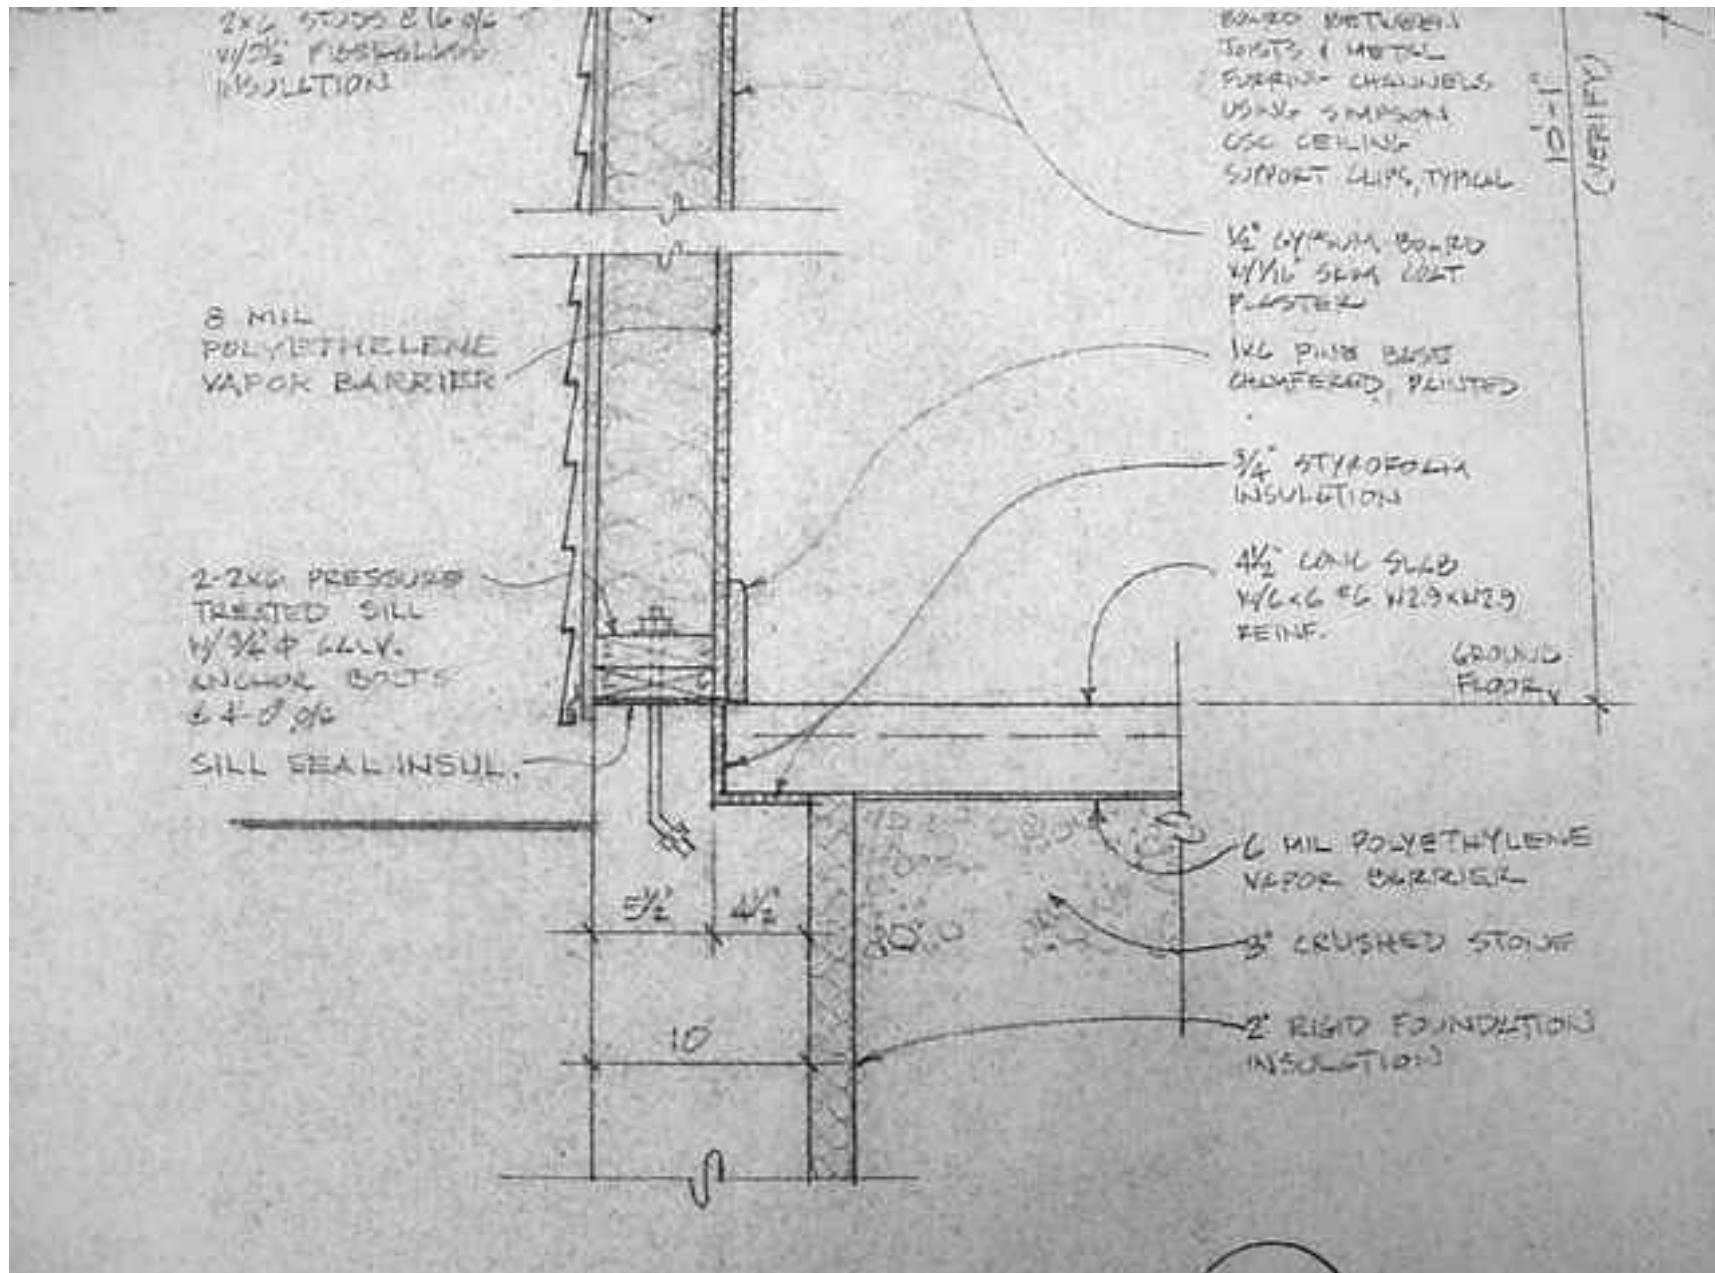
Blueprint 4

- The basement floor of the new wing is constructed with a 6 mm polyethylene vapor barrier (Blueprint 4). The purpose of a vapor barrier is to prevent moisture penetration through the slab of the basement floor. It is possible that the vapor barrier is allowing moisture to pool between it and the carpet to serve as a source that continuously moistens the carpet and other materials in contact with the floor.
- The exterior wall of the new wing appears to contain fiberglass insulation (Blueprint 4), which was not removed as part of the remediation efforts.

Blueprint Detailing Vapor Barrier, Wall Insulation and Weep Holes

- Environmental Protection Agency (US EPA, 2001). Consider replacing carpeting with a non-slip, nonporous material (e.g., rubber matting, tile).
2. Once carpet is removed, use ventilation and dehumidifiers to draw moisture from the cement floor that exists above the slab vapor barrier.
